PROJECT: Hoehne School District Facility Masterplan

SUBJECT: Planning Advisory Team #1 Meeting Minutes

Hoehne School District Master Plan

Structural and Envelope Issues

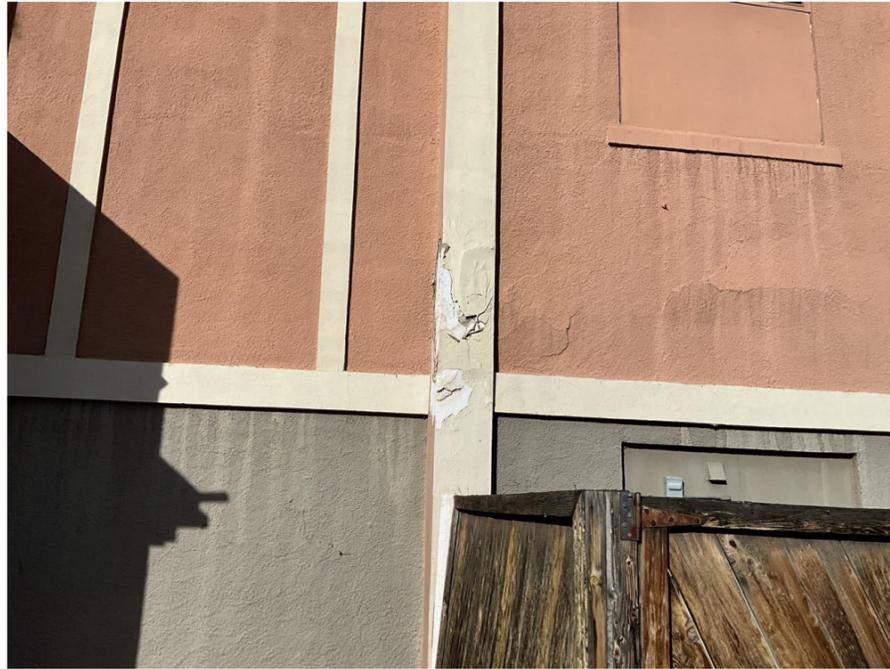
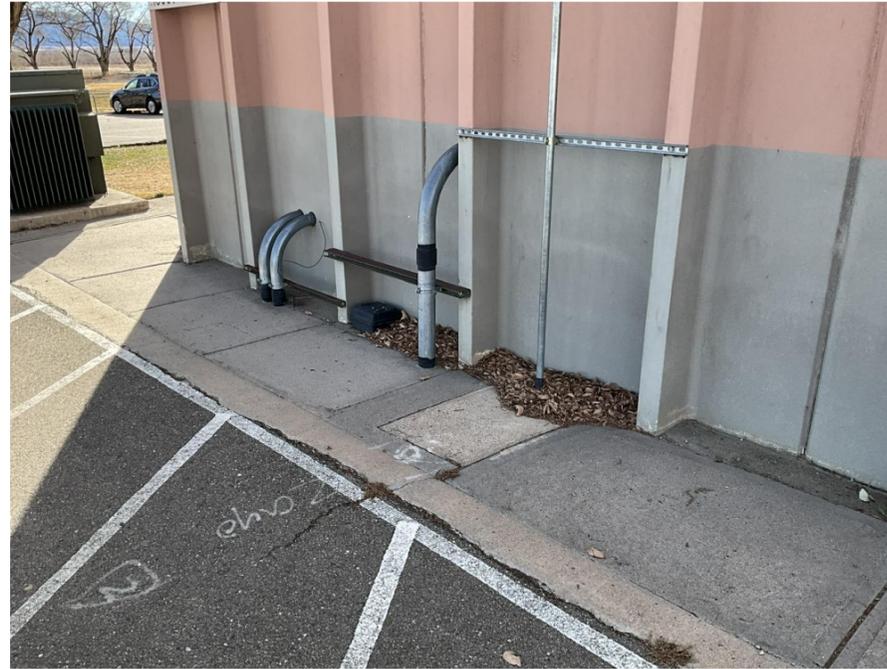
Repair or replacement of damaged or deteriorated structural elements (e.g., columns, walls, soffits, roofs)

Tuckpointing and masonry repairs

- Brian uses photos to demonstrate the deteriorated exterior issues, including one structural concern on the old gymnasium.
- Additional images show non-compliant Accessibility issues throughout the building, including restrooms, signage, gym bleachers, and missing handrails.

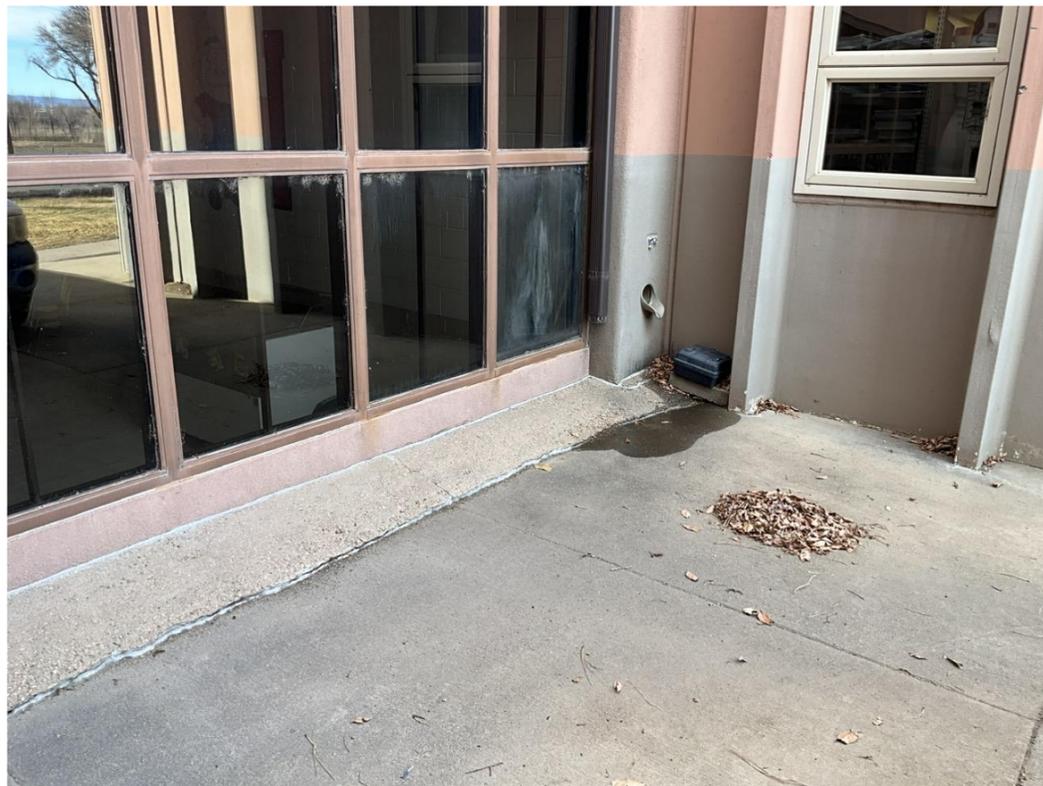
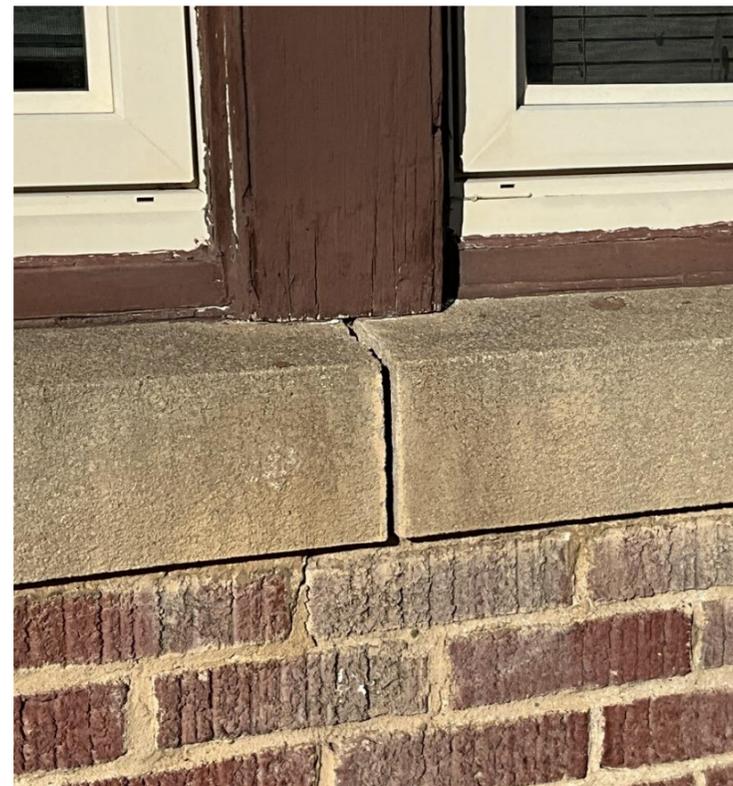
Replacement of exterior doors, windows, and precast panels

Regrading for drainage and site improvements

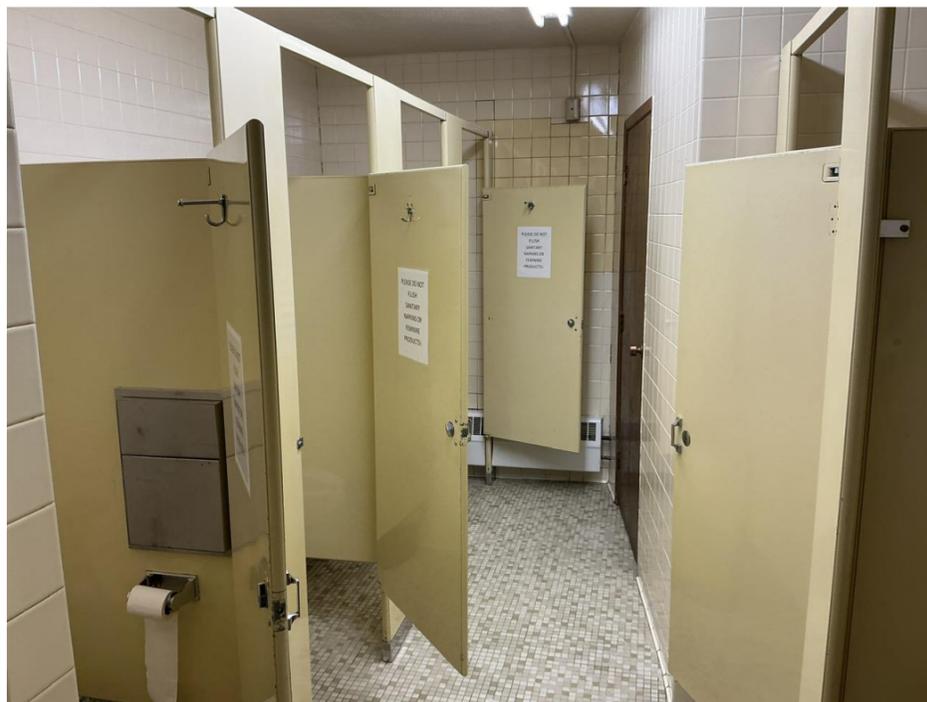
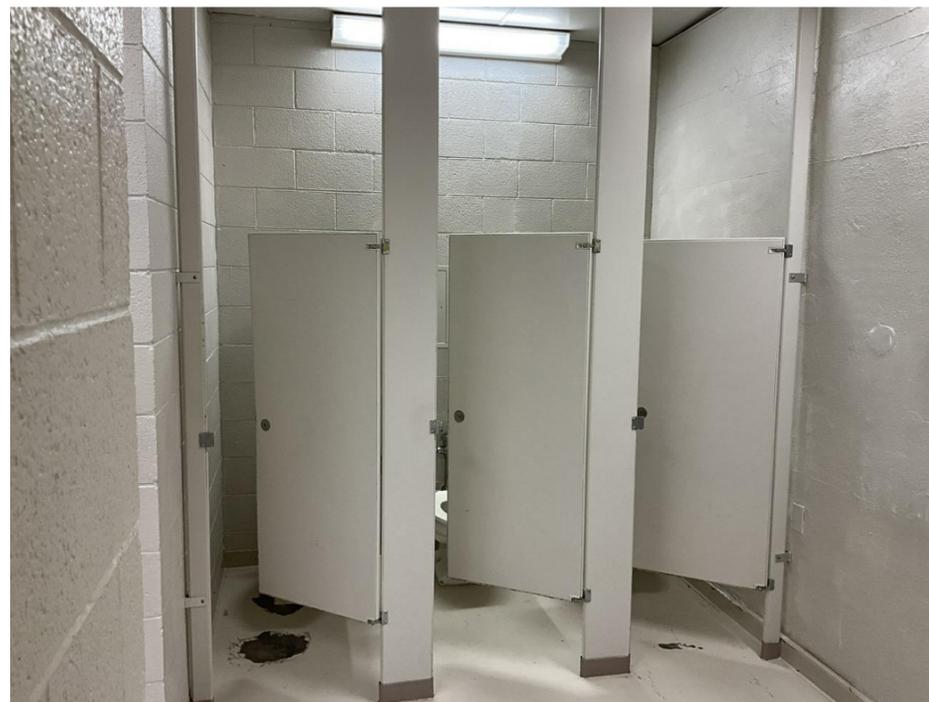
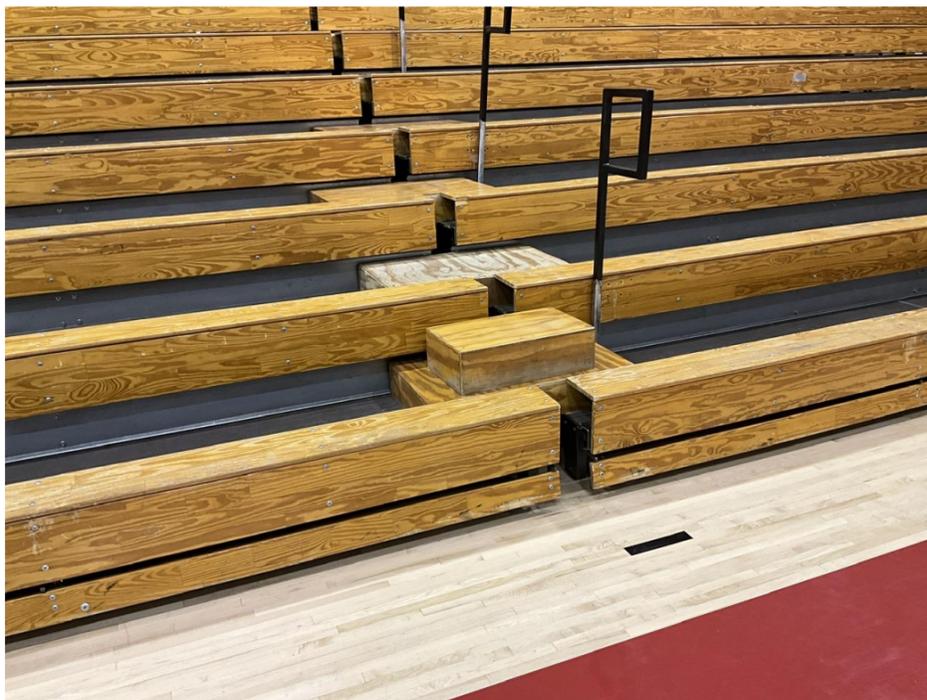
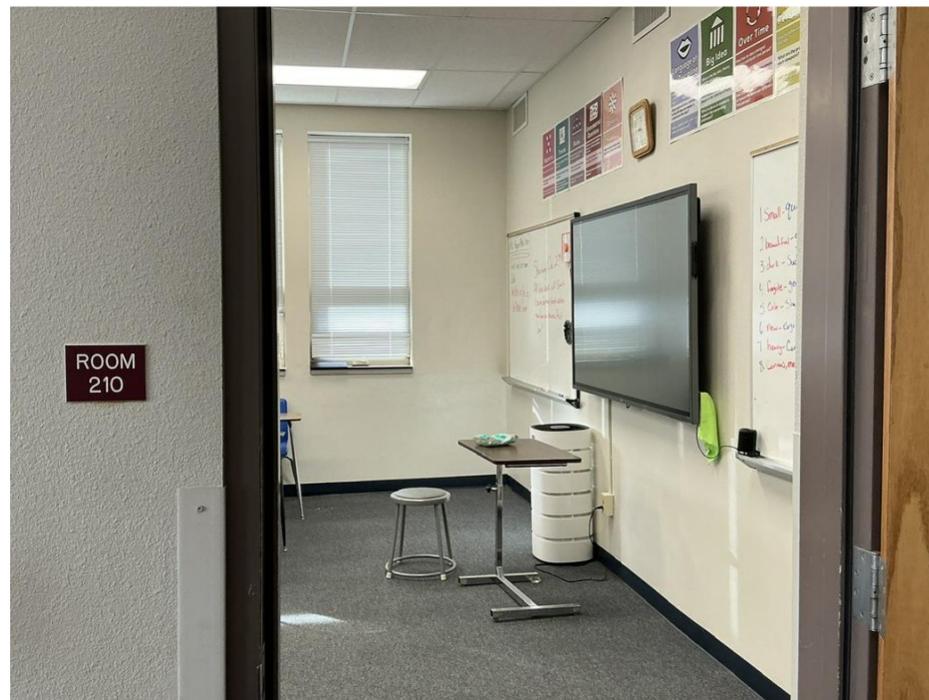
Accessibility (ADA) Compliance

Upgrades to restrooms, locker rooms, and entries for ADA compliance (e.g., sinks, toilets, showers, lockers, **signage**, handrails)

Installation of ADA-compliant bleachers and drinking fountains

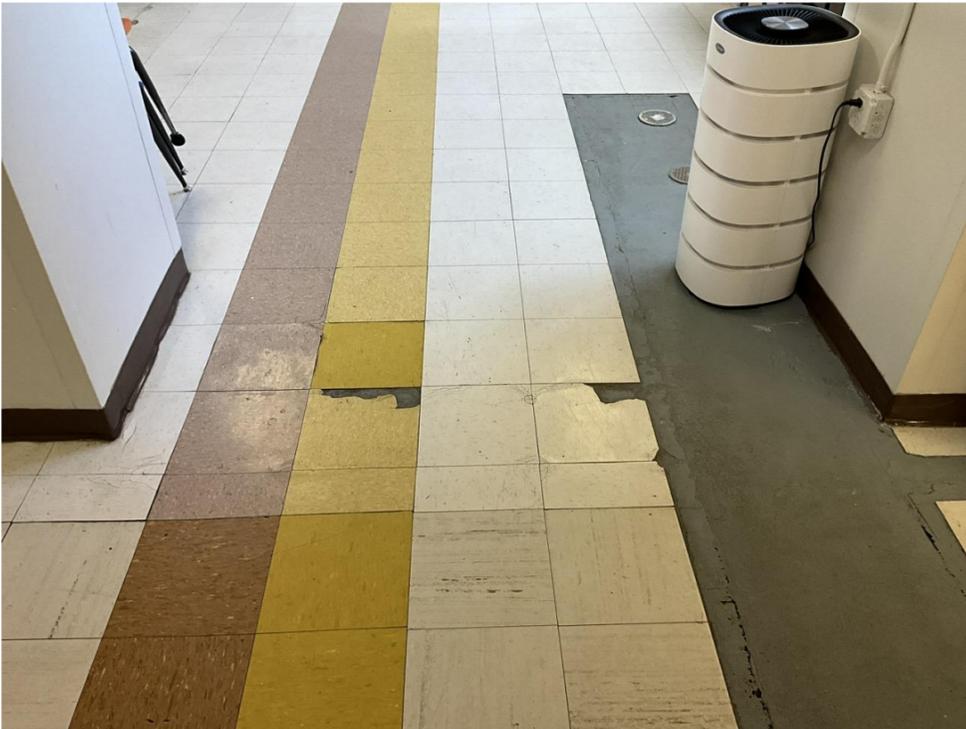
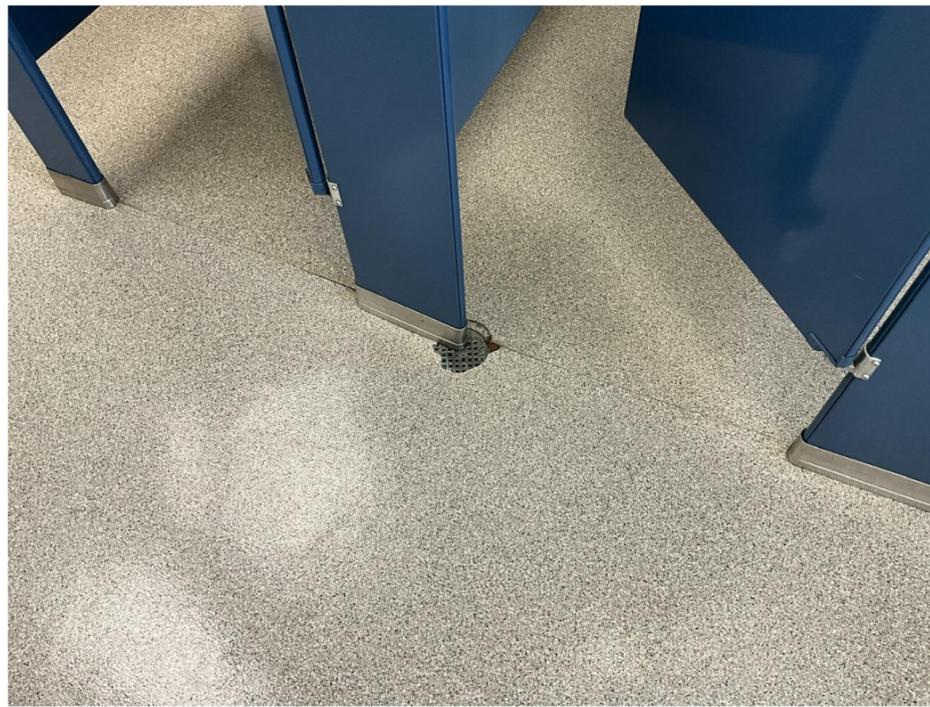
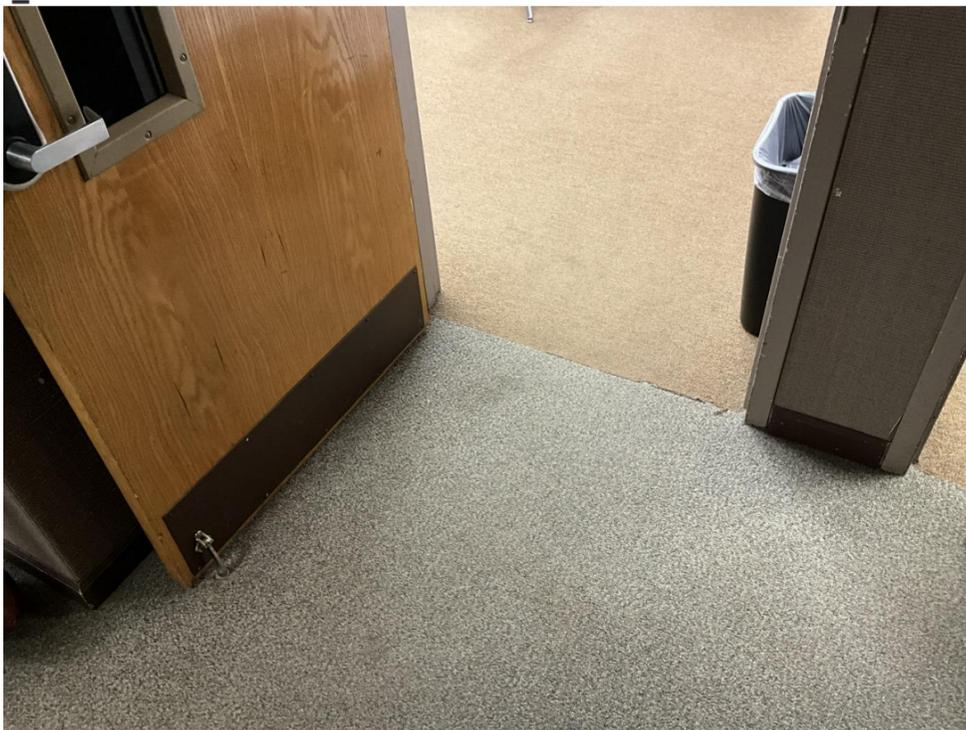
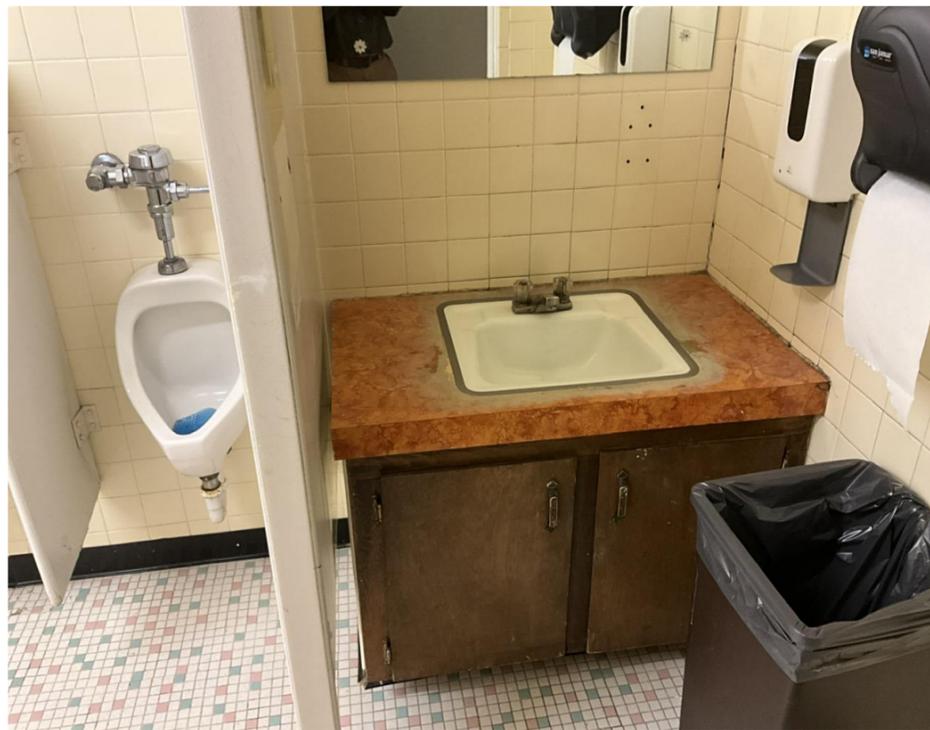
Interior Finishes and Fixtures

Replacement of worn or damaged flooring, carpeting, ceiling tiles, and casework

Repair or replacement of interior doors, partitions, and cabinetry

Painting and refinishing of interior surfaces

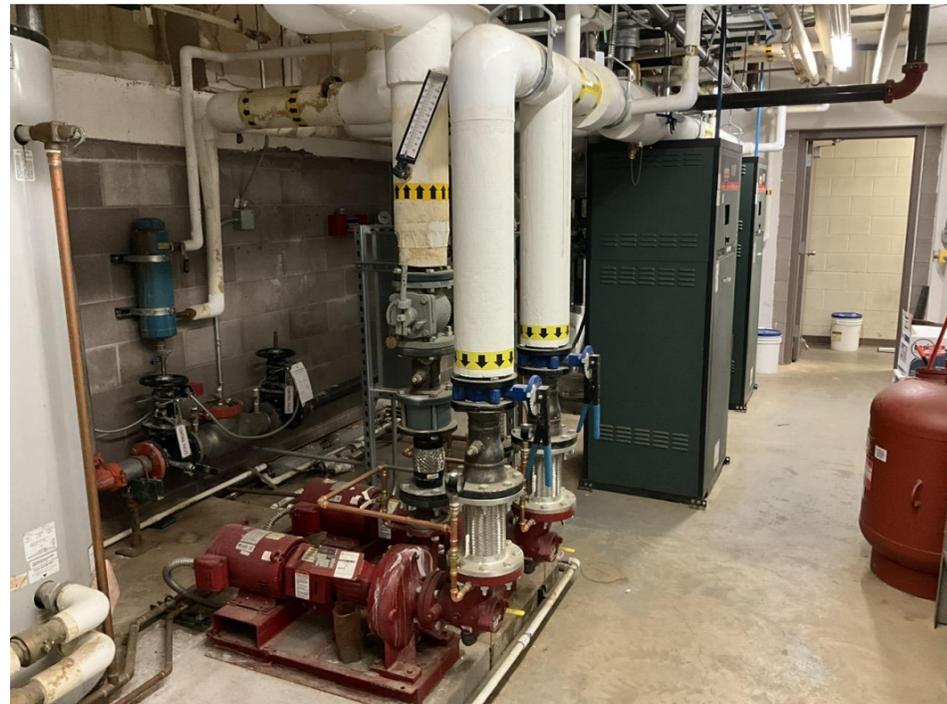
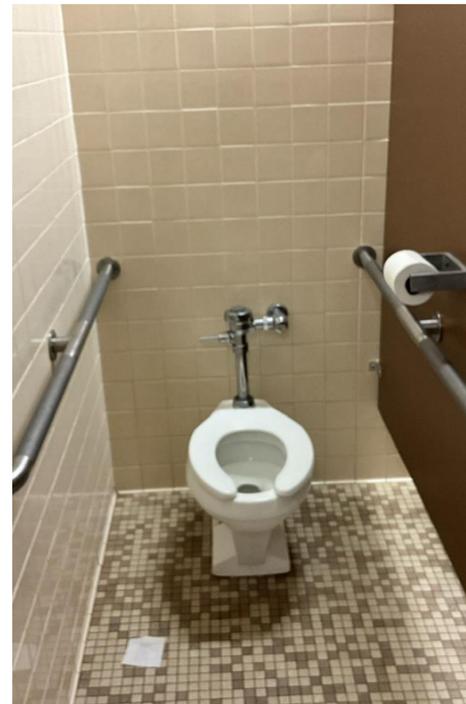
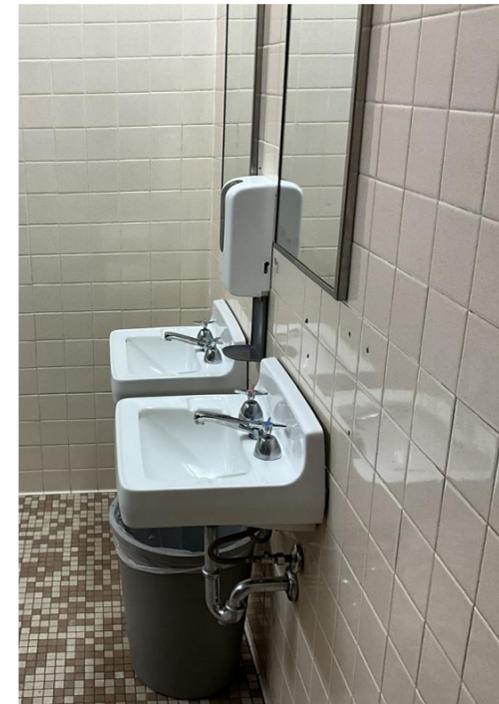
Mechanical, Electrical, and Plumbing (MEP) Systems

Replacement of aging HVAC equipment (boilers, pumps, rooftop units, exhaust fans, VAV boxes)

Upgrades to plumbing fixtures, water lines, and sewer lines

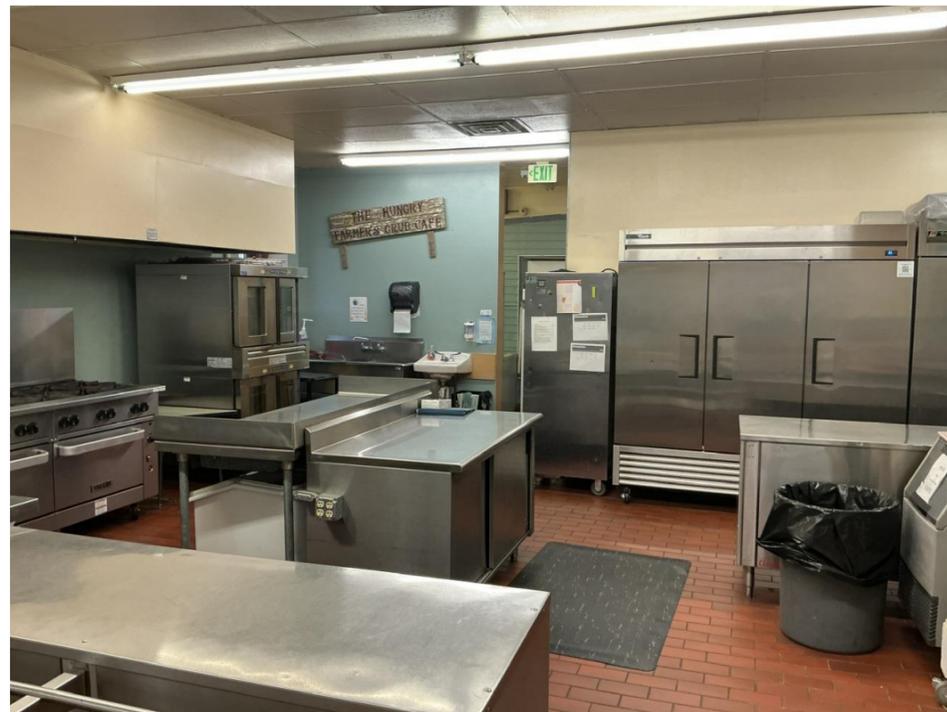
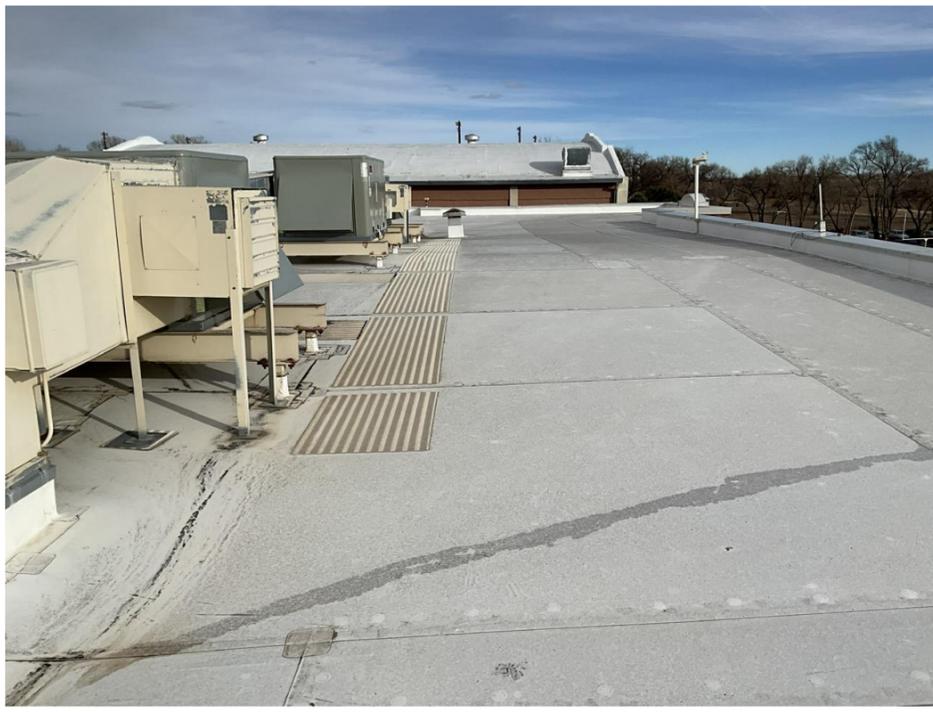
Installation of dedicated cooling for IT rooms and upgrades to kitchen exhaust systems

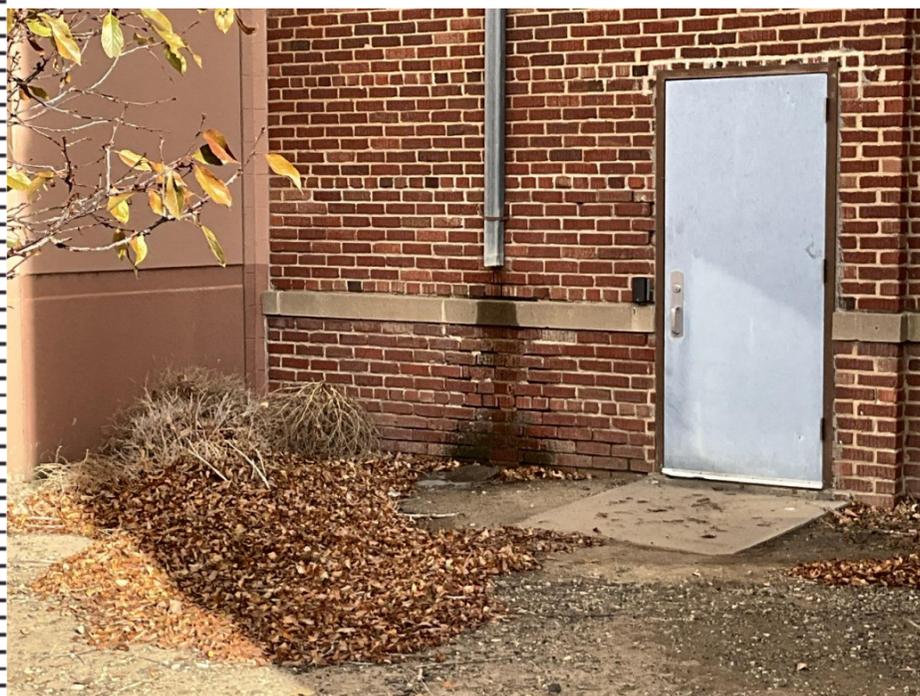
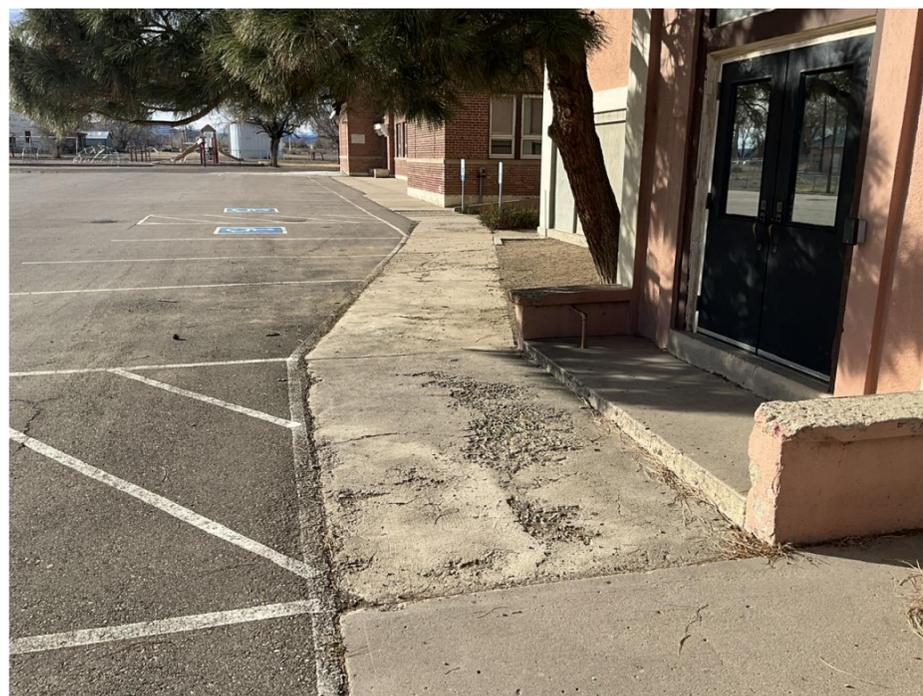
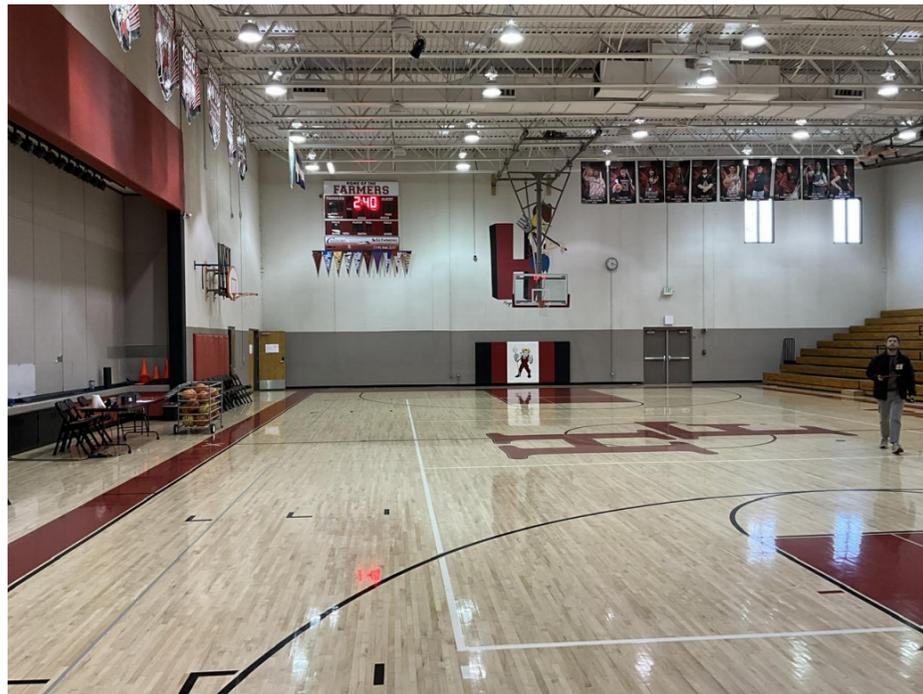
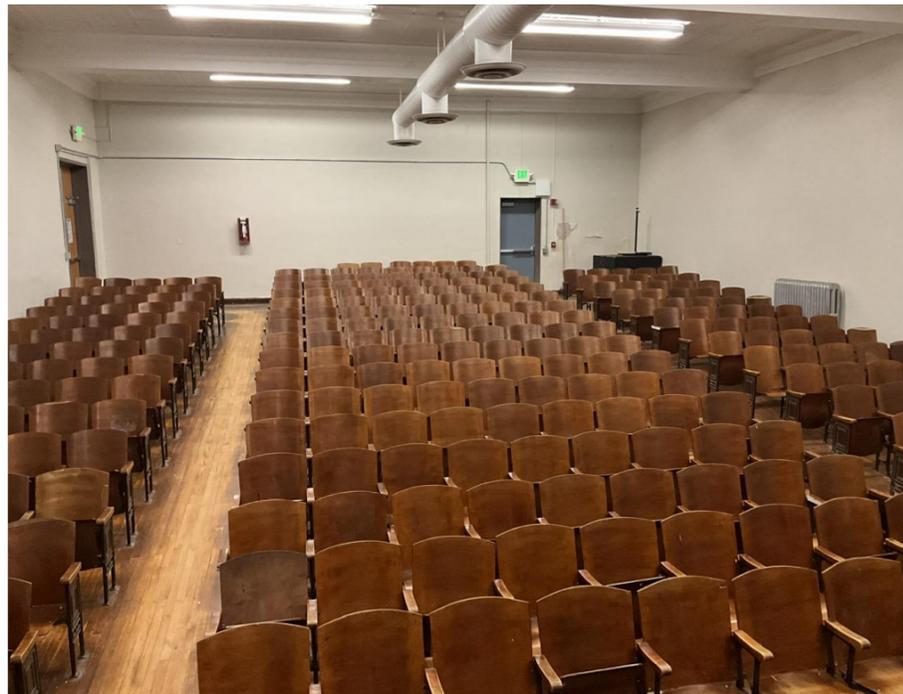
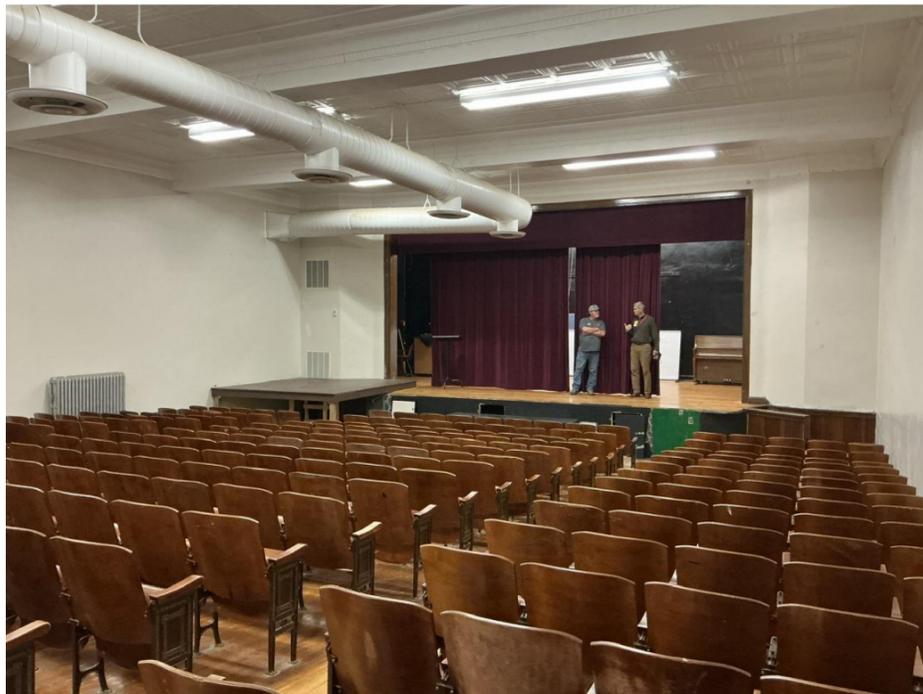
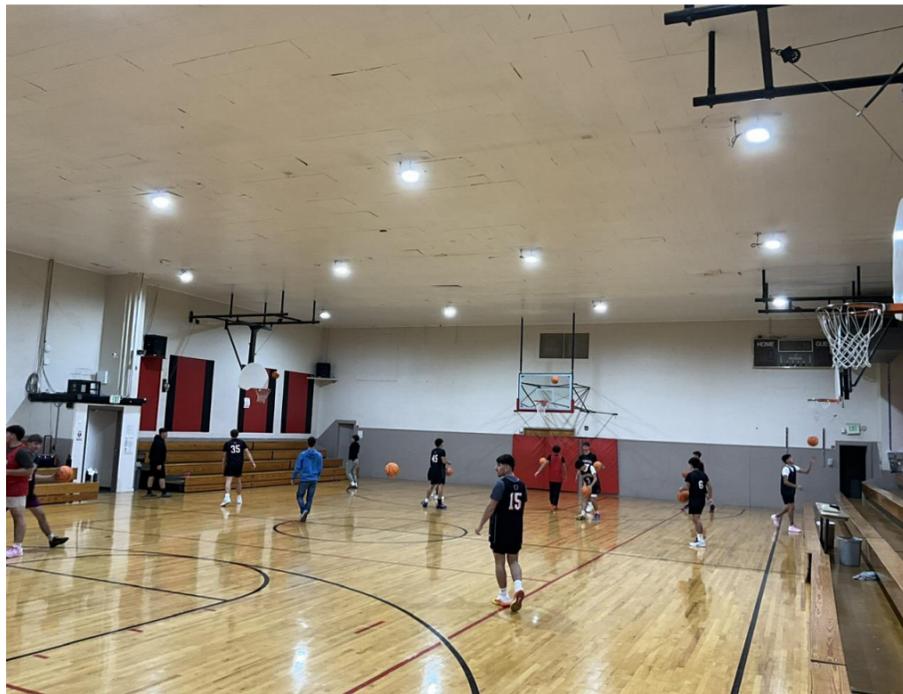
Site and Exterior Improvements

Replacement or repair of sidewalks, asphalt, and concrete stoops

Landscaping for dirt areas and improvements to playgrounds and athletic fields

Drainage improvements around buildings and parking areas

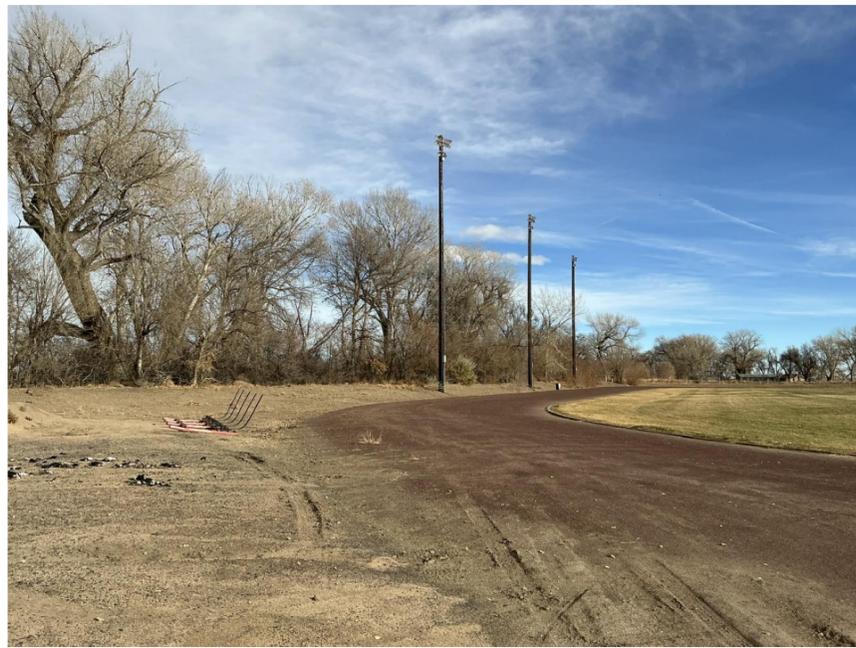
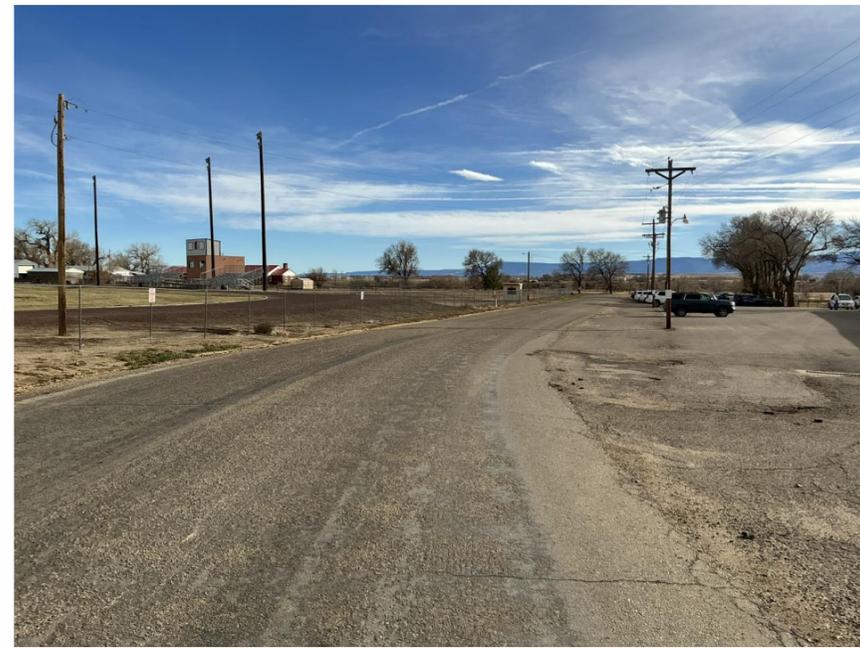
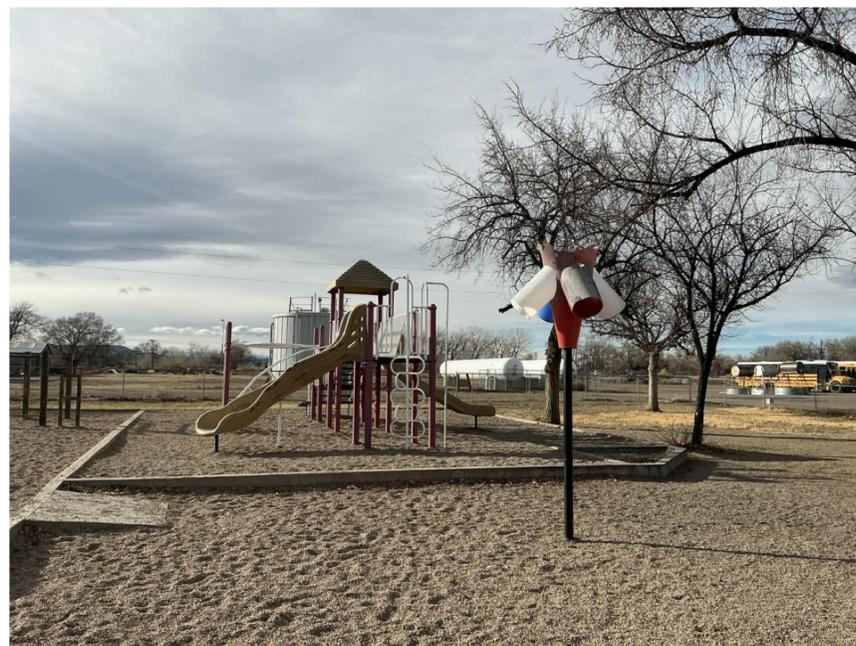
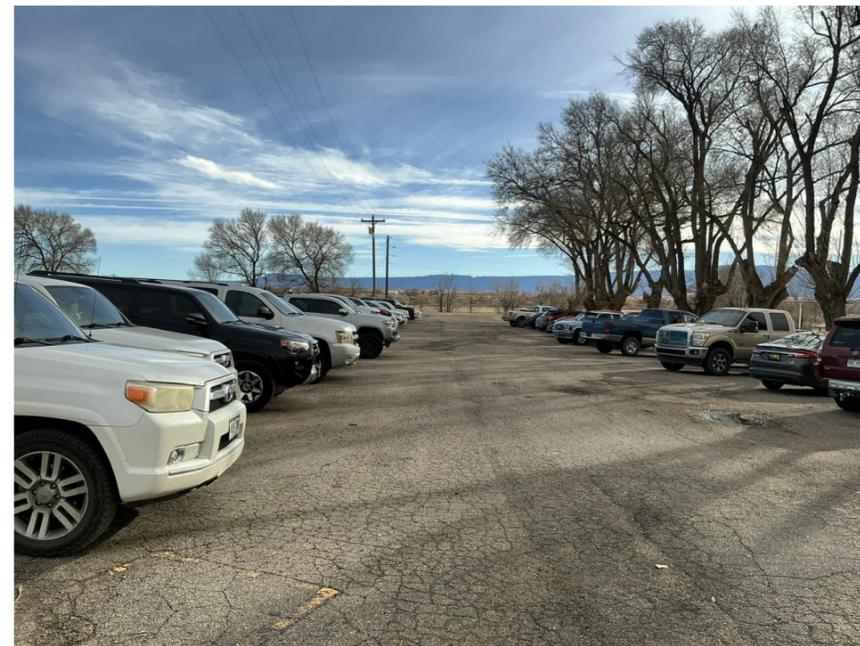
Critical Deficiencies

Outdoor Spaces: Extremely low score (18%). Poor playground condition, inadequate ADA access, and aging athletic fields.

Traffic Flow & Parking: Poor signage, lack of traffic calming, and deteriorated parking lot conditions.

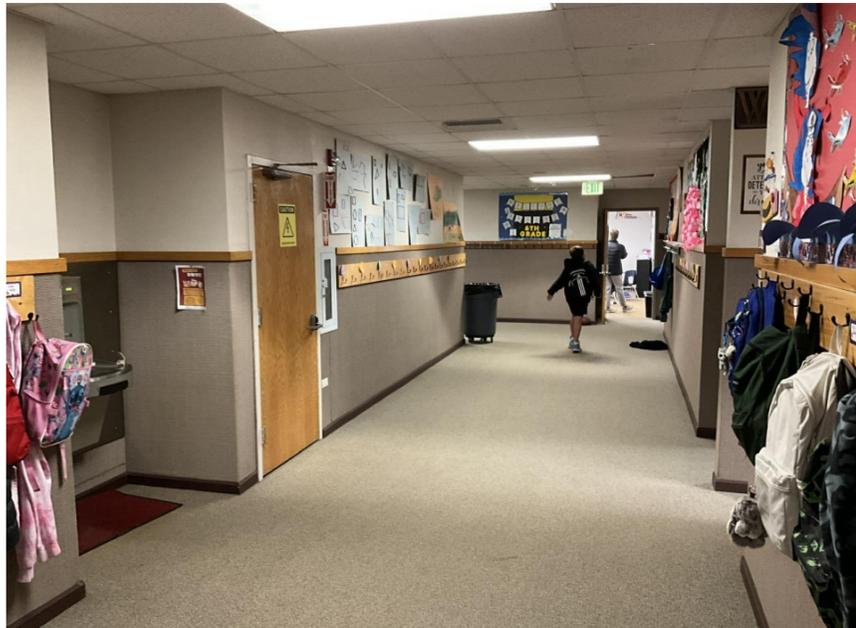
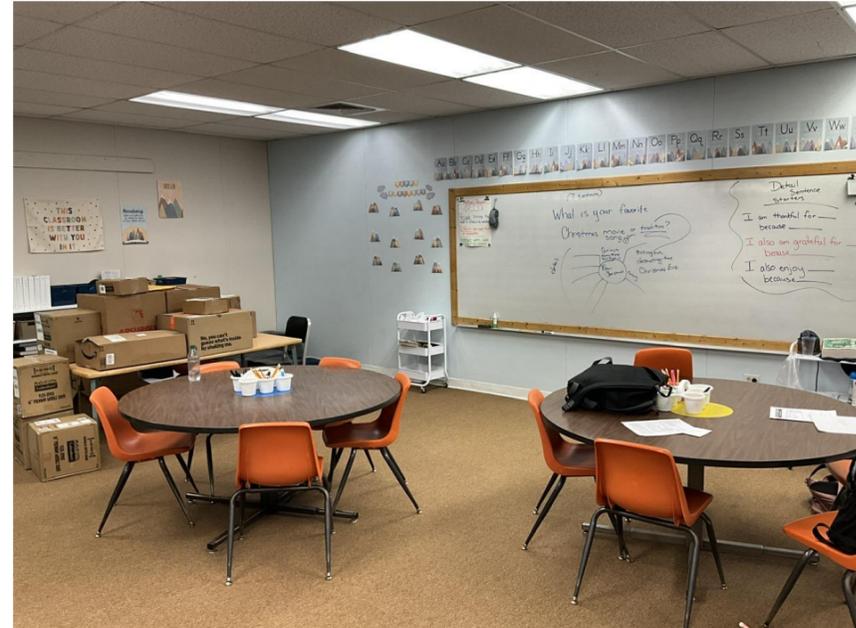
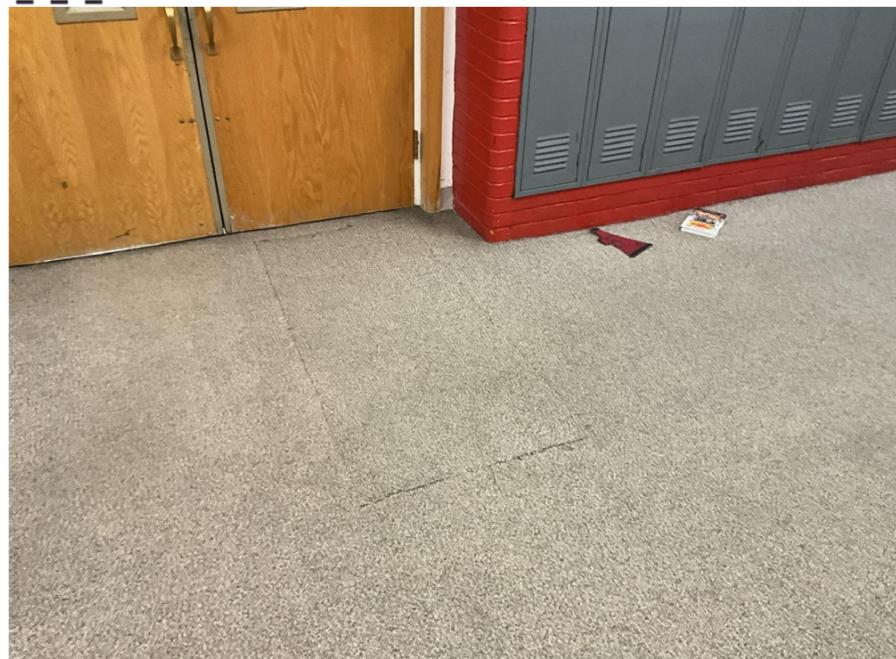
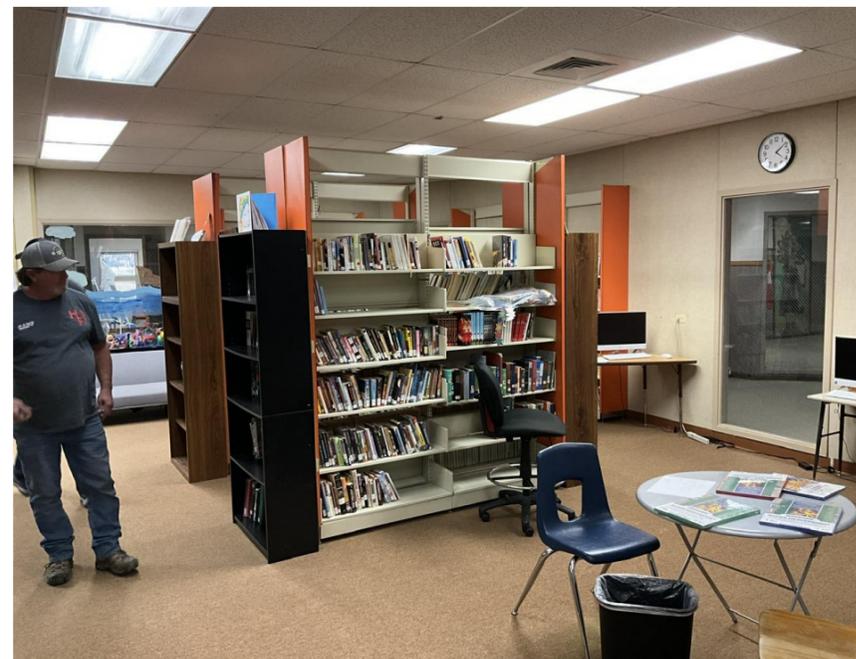
Critical Deficiencies (cont.)

Classroom Collaboration: No teaming areas for ES, MS, or HS; classrooms mostly traditional lecture style for MS/HS.

Building Condition: Dated finishes, flooring, lighting issues, and convoluted circulation due to multiple additions.

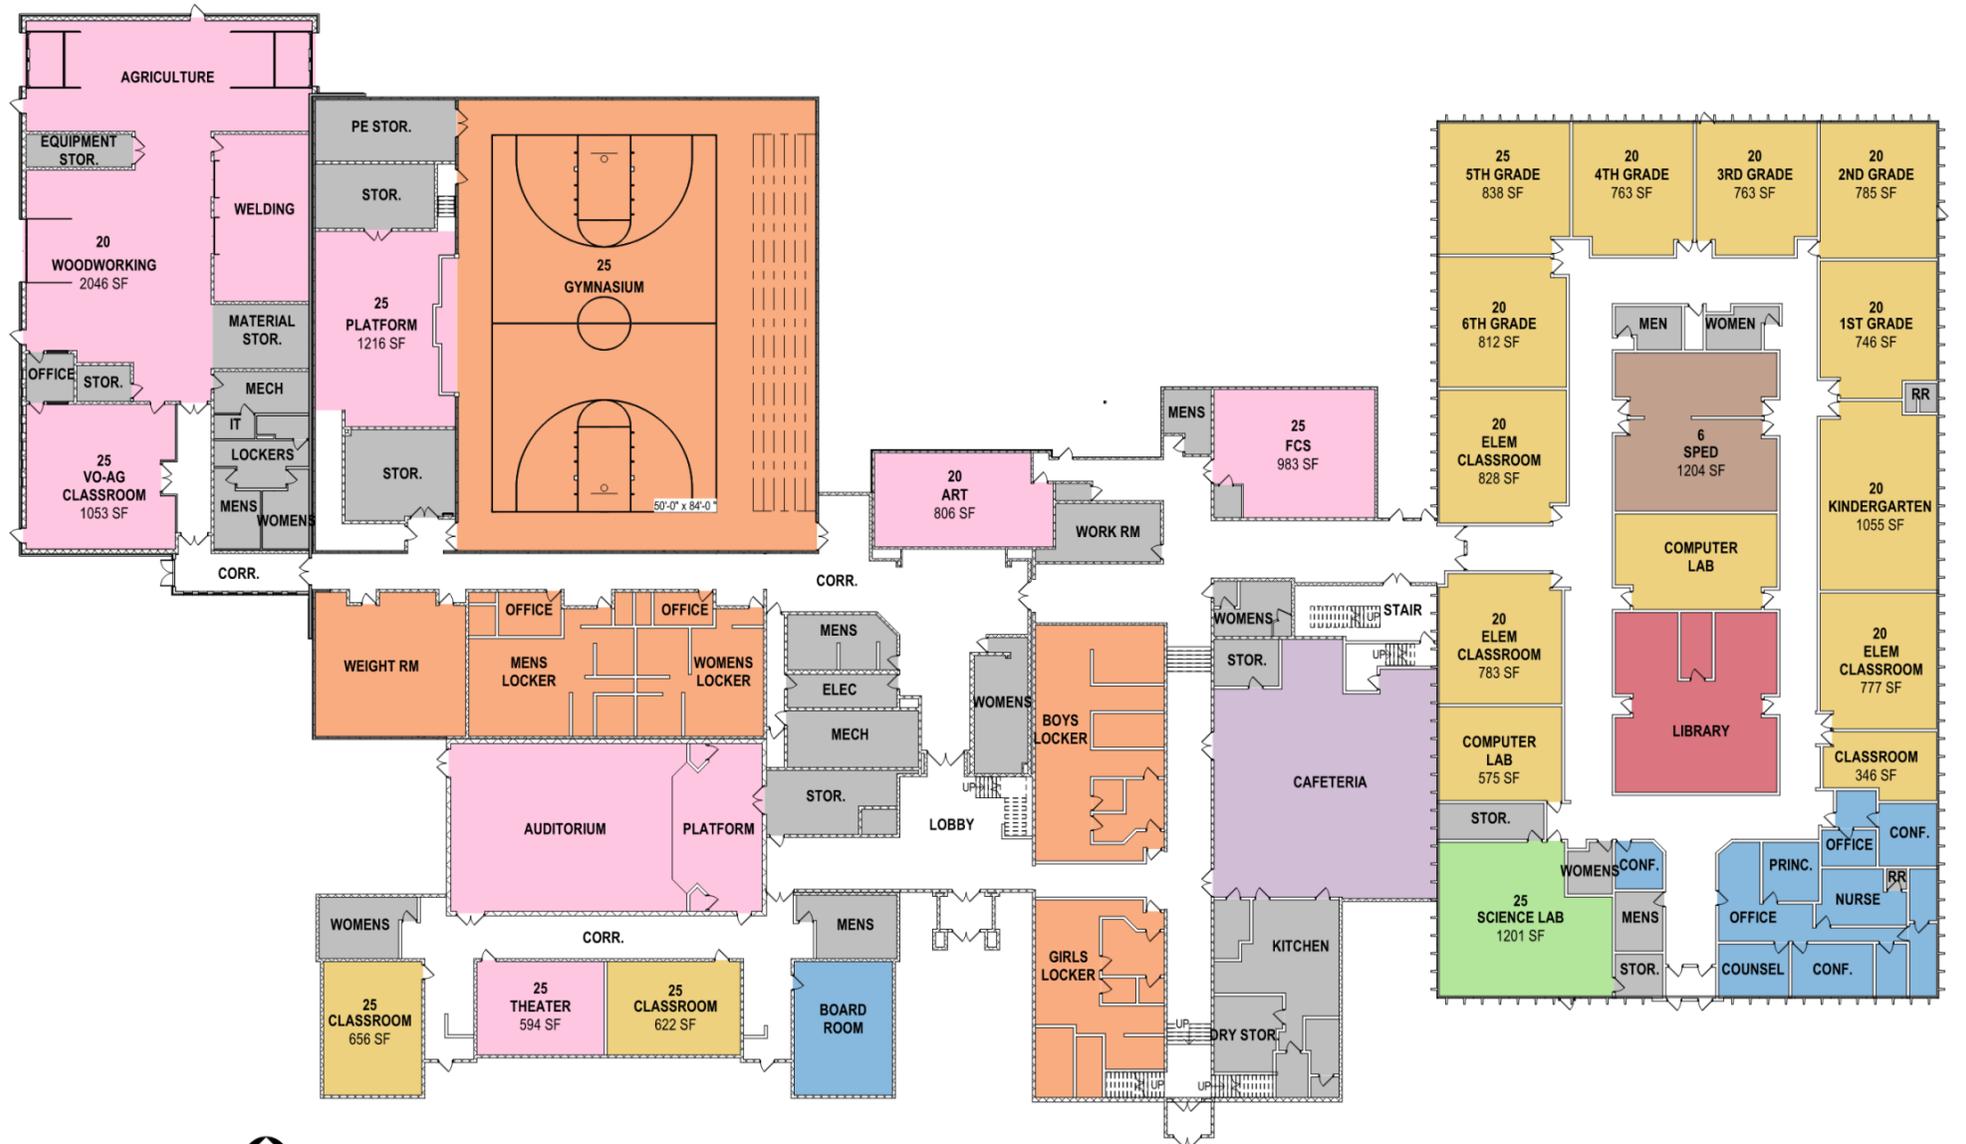
2ND FLOOR PLAN
1" = 20'-0"

EDUCATIONAL DEPARTMENT LEGEND

- ADMINISTRATION
- INSTRUCTIONAL AREAS
- ARTS / VO-AG
- SCIENCE
- DINING / COMMONS
- LIBRARY
- PE / ATHLETICS
- SPECIAL EDUCATION
- SUPPORT / INTERVENTION

1ST FLOOR PLAN
1" = 20'-0"

- Ben explains the difference between Building Capacity and Program Capacity and shows a departmental floor plan of the building and how he arrived at that program capacity.
